Manhole Inspection Summary

Manhole # S53K__042MH

Insp Date: **4/8/08 3:50 PM**

Location Address: **711 Ellwood Robinson**

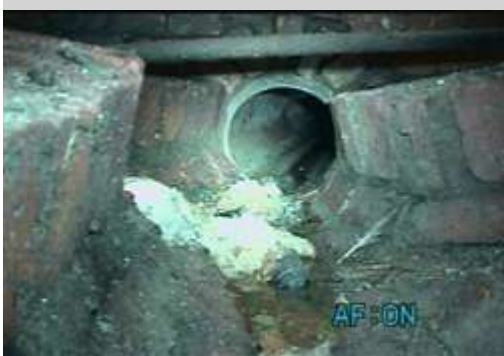
Misc

channel debris

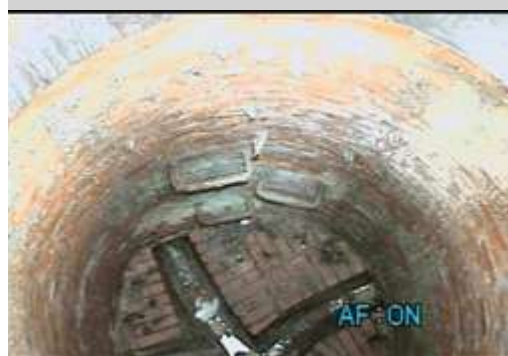
Defect 1

Steps Count: **6** Missing: **3** ☒ **Corroded**

corroded steps

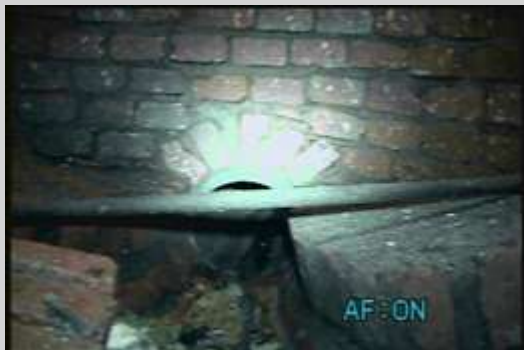
12 O'Clock Outflow

8 in. Circular Gravity Sewer
Pipe Out @ 12 O'Clock

Pipe Material: **Clay** ☐ Pipe Lined

Invert Depth: **9.46** (ft.) Flow Characteristics: **Slow**

Deposits: ☒ None ☐ Mud ☐ Sludge ☐ Debris ☐ Grease

Infiltration: **None** Pipe Seal Cond: **Unknown**

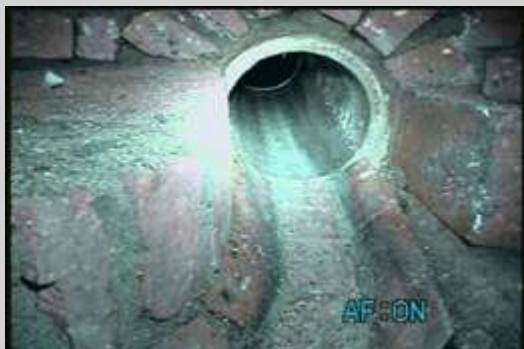
3 O'Clock Inflow

8 in. Circular Gravity Sewer
Pipe In @ 3 O'Clock

Pipe Material: **Clay** ☐ Pipe Lined

Invert Depth: **8.70** (ft.) Flow Characteristics: **None**

Deposits: ☒ None ☐ Mud ☐ Sludge ☐ Debris ☐ Grease

Infiltration: **None** Pipe Seal Cond: **Unknown**

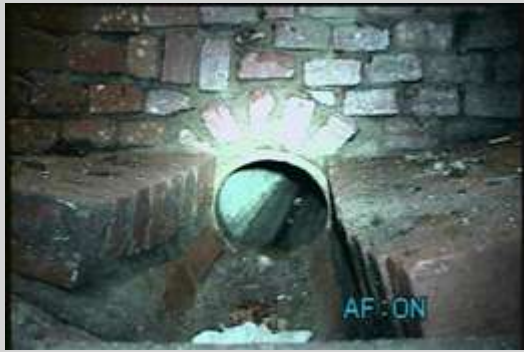
6 O'Clock Inflow

Pipe In @ 6 O'Clock

Pipe Material: **Clay** ☐ Pipe Lined

Invert Depth: **9.30** (ft.) Flow Characteristics: **Slow**

Deposits: ☒ None ☐ Mud ☐ Sludge ☐ Debris ☐ Grease

Infiltration: **None** Pipe Seal Cond: **Unknown**

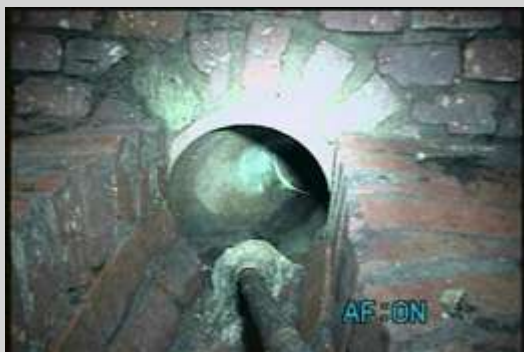
9 O'Clock Inflow

Pipe In @ 9 O'Clock

Pipe Material: **Clay** ☐ Pipe Lined

Invert Depth: **8.88** (ft.) Flow Characteristics: **None**

Deposits: ☒ None ☐ Mud ☐ Sludge ☐ Debris ☐ Grease

Infiltration: **None**

Connects To: **House connection / Service line**
